# Report into the Grounding of the reefer

## **'Frio Chikuma'**

Port William, Falkland Islands  
3<sup>rd</sup> April 2024

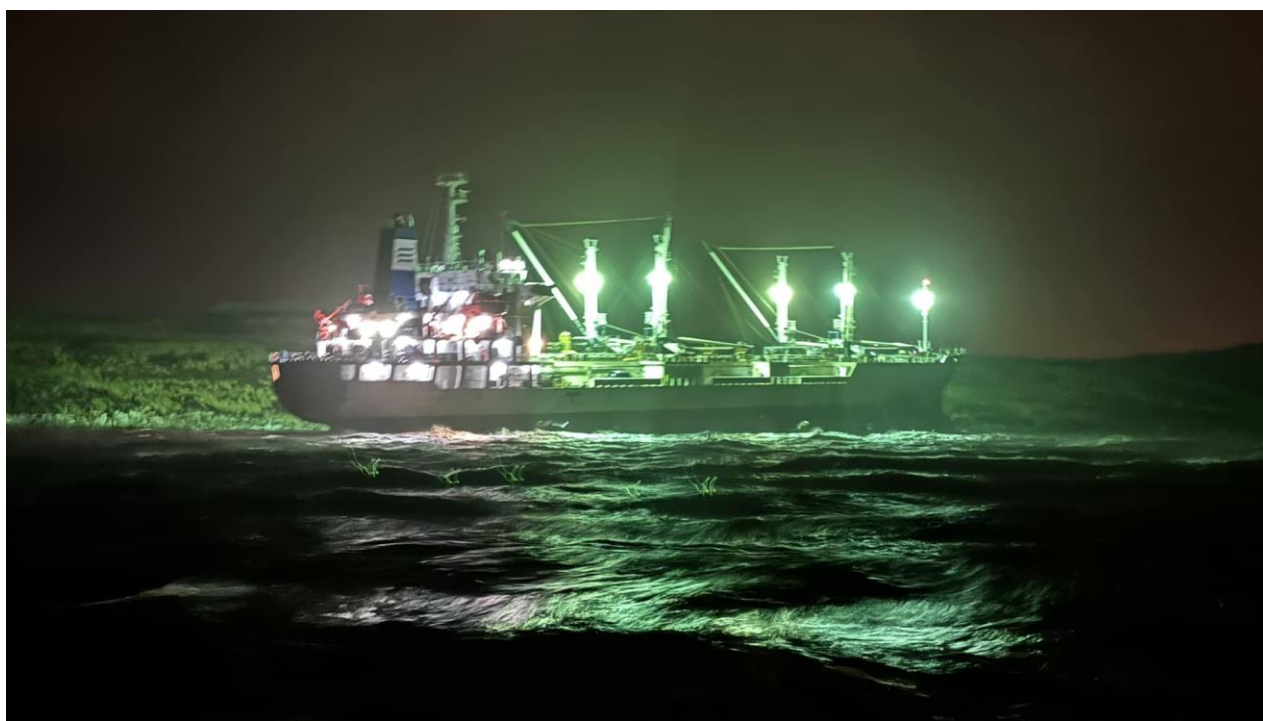
**Figure 4:** *Frio Chikuma* aground – Photo courtesy of *Clio FI*, FIC

**0115** The vessel runs aground (**Figure 2**) on its port side with five shackles out on its starboard anchor. The anchor cable is caught around the bulbous bow and under the vessel (**Figure 5**). The Master makes a call to Stanley Port Control to advise them that the vessel is aground.

At 0220 the HM called the Managing Director (MD) from SSL (the agent for the *Frio Chikuma*). At 0223 FIMA received an email from the Coxswain of *Clio FI* with a photo of the grounded vessel (**Figure 4**).

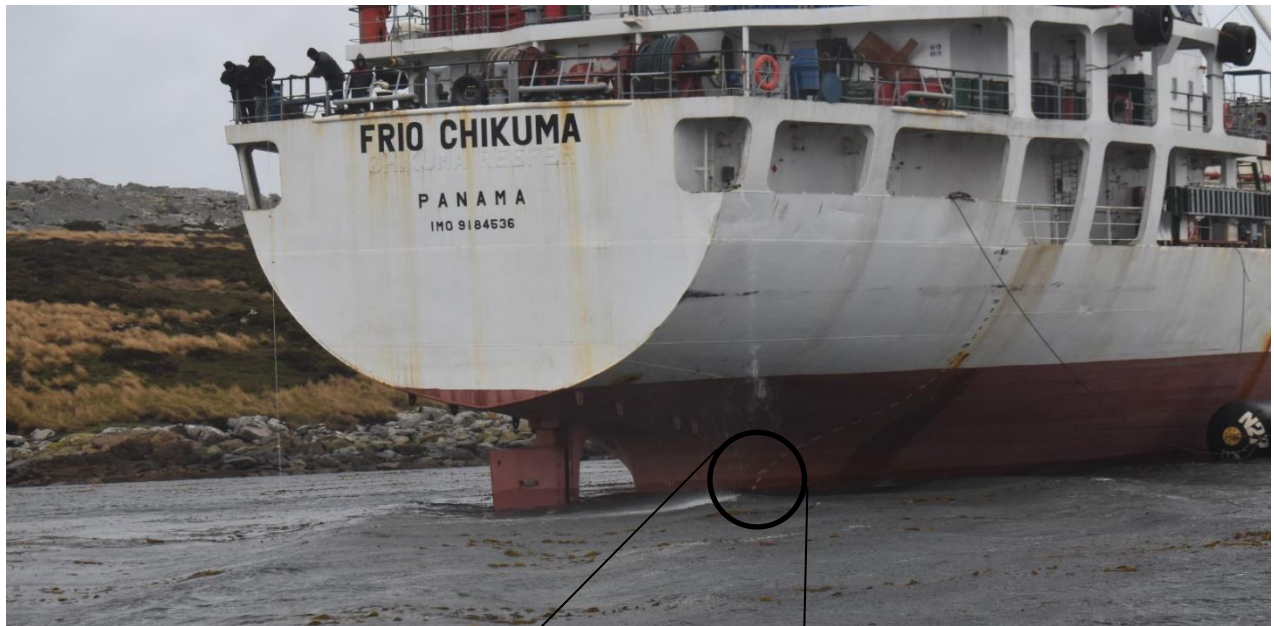
During first light, the FPV *Lilibet* sent her Rigid Hull Inflatable Boat (RHIB) ashore to take some photos of the vessel and to check around the vessel for any signs of pollution (**Figure 5 & 6**).

**Figure 5:** Aft draft marks of *Frio Chikuma* while aground with an aft draft of approximately 4.6m – Photo courtesy of DNR, FIG

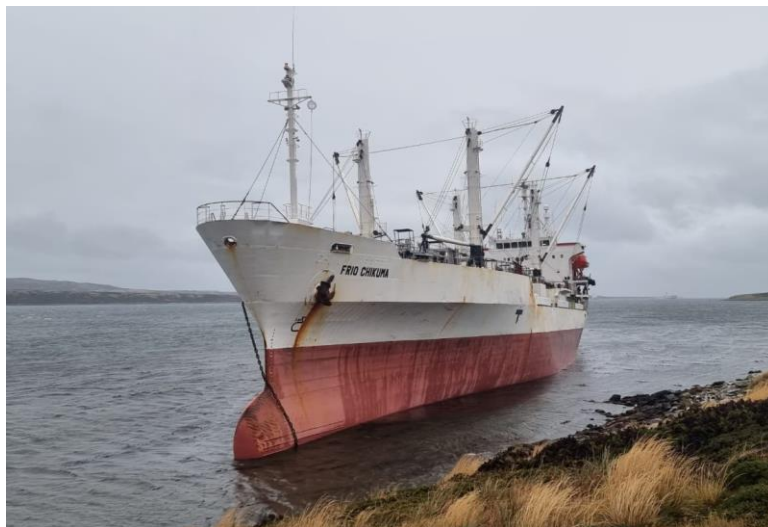
**Figure 6:** Starboard anchor chain caught under the bulbous bow – Photo courtesy of DNR, FIG

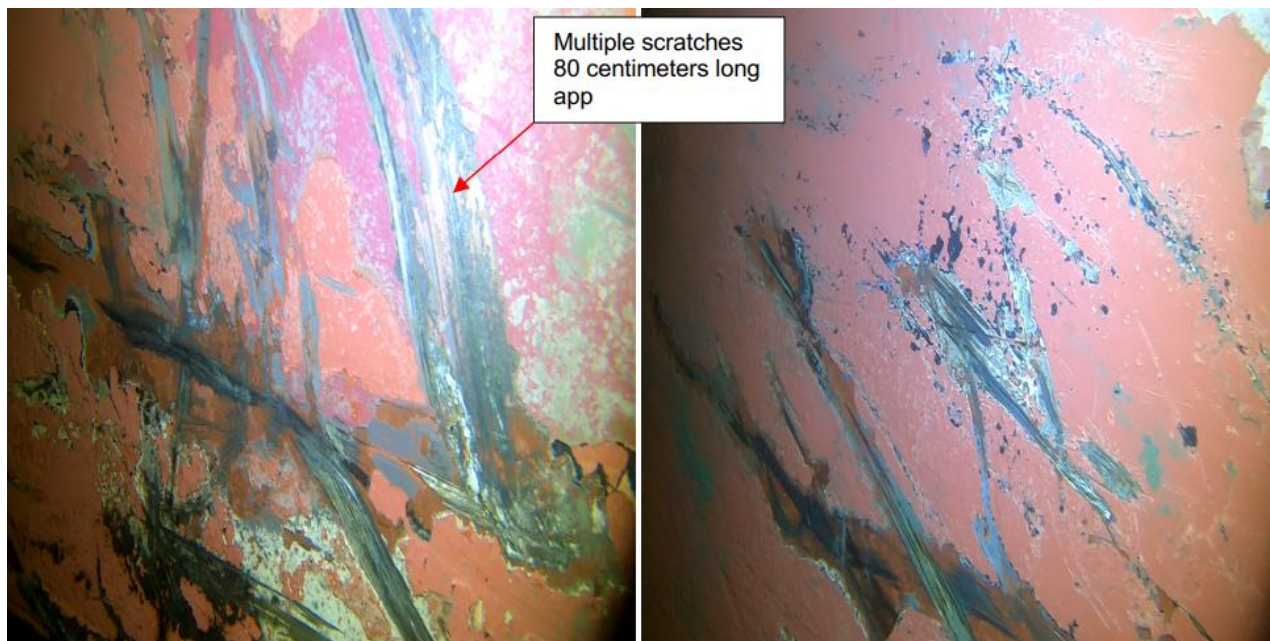
It was reported that the rudder had evidence of multiple bumps and scratches but had no significant damage and was in working order (**Figure 10**). Although it was reported that the Master took action to stop the propeller before the vessel ran aground, the propeller blades received damage.

**Figure 10:** Port side rudder showing deep scratched paint work through to the steel

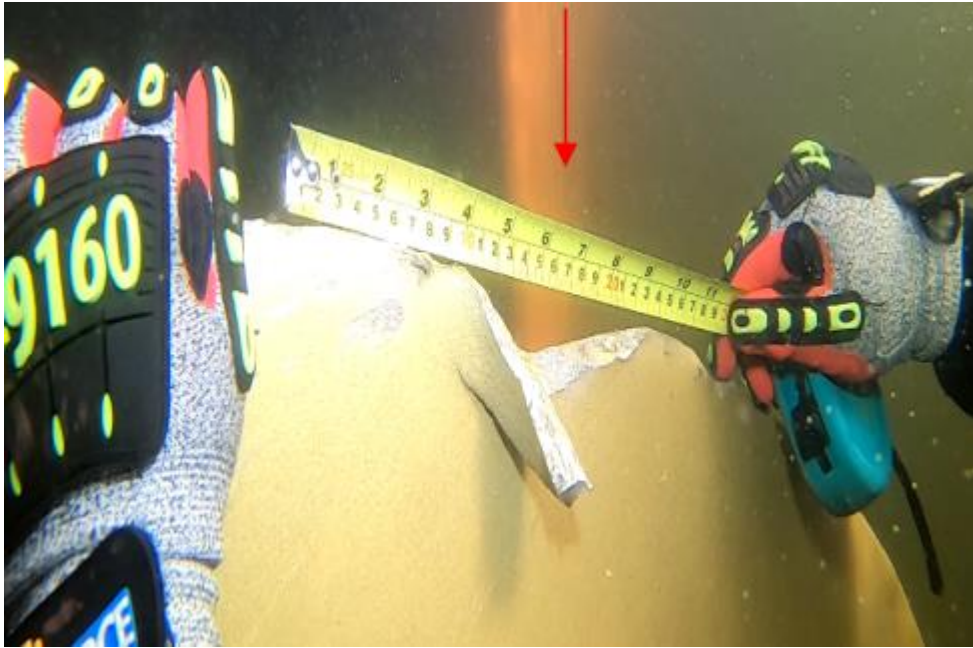
The propeller on the *Frio Chuikuma* is a fixed pitch 5 bladed propeller. Each of the 5 blades had some damage on their leading edge (**Figure 11 & 12**).

**Figure 11:** Damage to the tip of the propeller blade

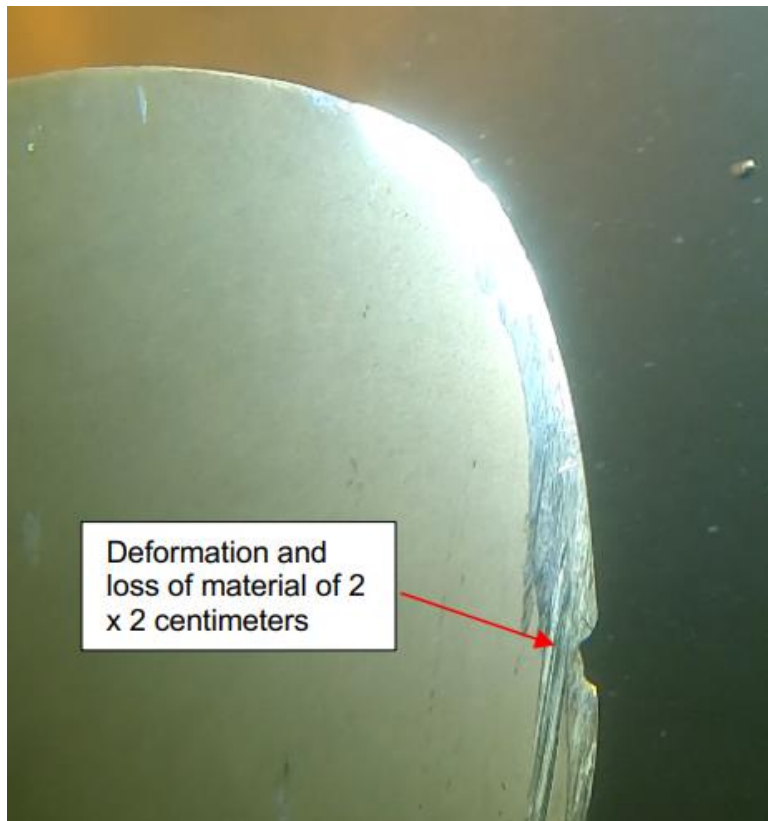
**Figure 12:** Further damage to the tip of the propeller blade

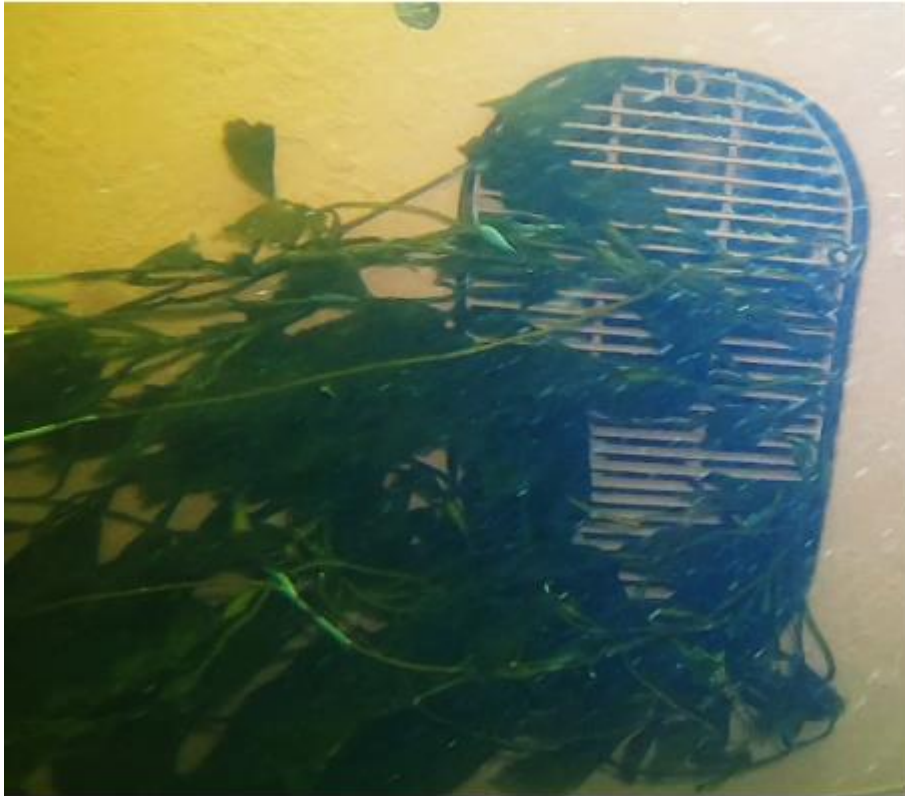
The buildup of kelp can be seen on the sea chest that had been sucked into the gratings which would have had an effect on the sea suction to some extent (**Figure 13**).

**Figure 13:** Starboard sea chest heavily fouled with Kelp
