Safety warning issued regarding the maintenance and use of working lifejackets and the maintenance and use of safety harnesses on board

Jigger fishing vessels

MARINE SAFETY BULLETIN 1/2026

The Falkland Islands Government is carrying out a marine safety accident investigation into three serious injuries and a man overboard leading to a fatality from fishing jigger *An Fong 138*, on 7 February 2026.

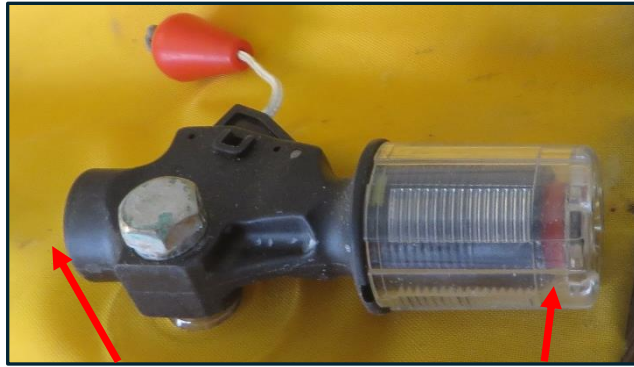
- One lifejacket was found to have its automatic device activated (**Figure 1**);
- Most life jackets were found to have heavily corroded Co2 gas cylinders due to prolonged exposure to salt water (**Figure 2**);

Figure 1: Automatic inflator activated and Co2 gas cylinder missing.

It is recommended that all working lifejackets on jiggers are inspected by a competent person to ensure they are fit for use and do not endanger the wearer.

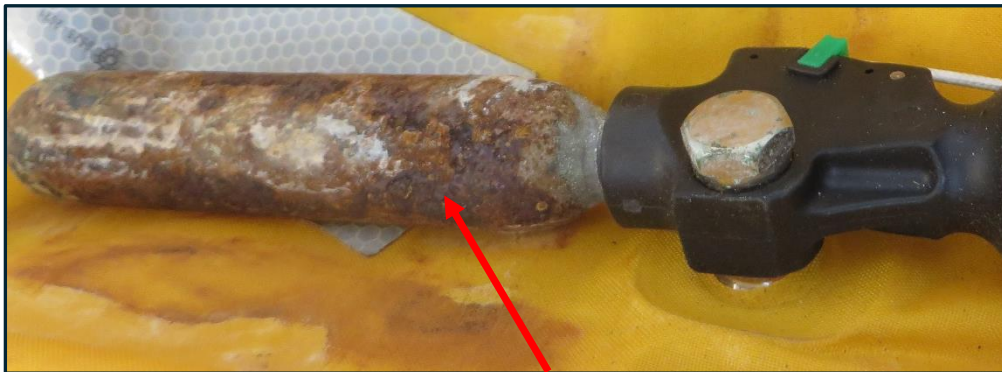
Figure 2: Co2 gas cylinder heavily corroded.

It is further recommended that lifejackets be stowed in the appropriate manner, away from salt water and in a dry place in accordance with the manufacturer's instructions. The owner should ensure that all crew issued with lifejackets have been given a demonstration on the correct use and donning procedure and that it is worn correctly.

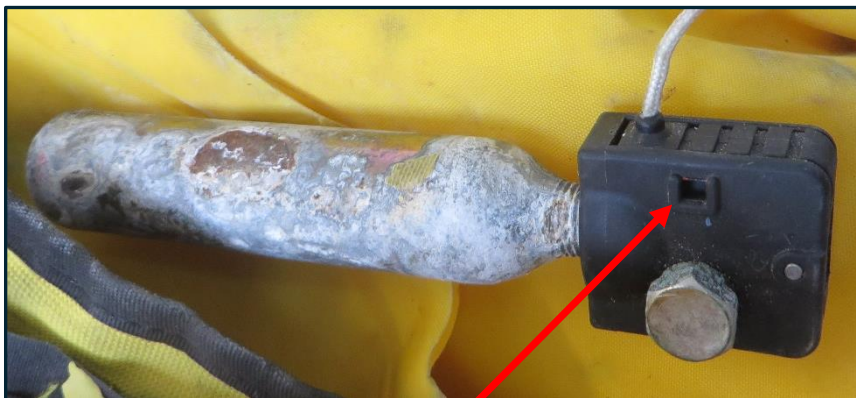
- Many lifejackets had the pull cord retention clip missing or broken (**Figure 3**);
- Some lifejackets found to be missing one or both Co2 gas cylinders (**Figure 4**);

Figure 3: Release cord retention clip missing.

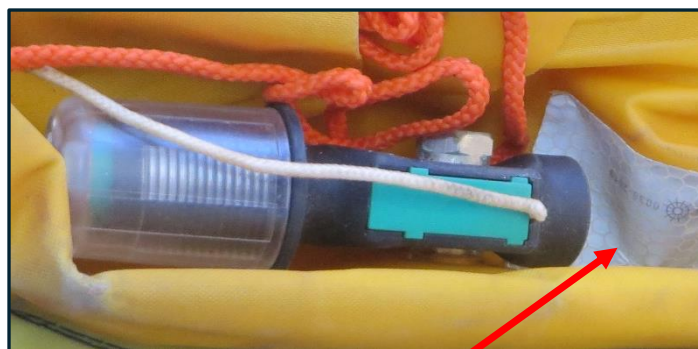
Figure 4: Co2 gas cylinder missing.

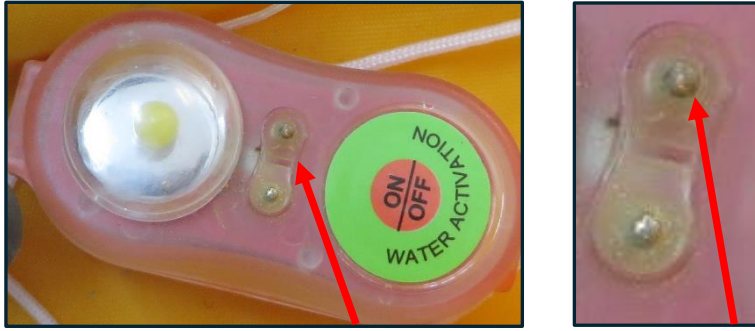
- In a large sample of lifejackets, none of the lights worked. The lights were all in date, however prolonged saltwater exposure caused the light to be activated and the battery had run flat. Exposure to salt water can be seen by the corroded contacts on the lifejacket light (**Figure 5**);

Figure 5: activation contacts on life jacket light corroded.

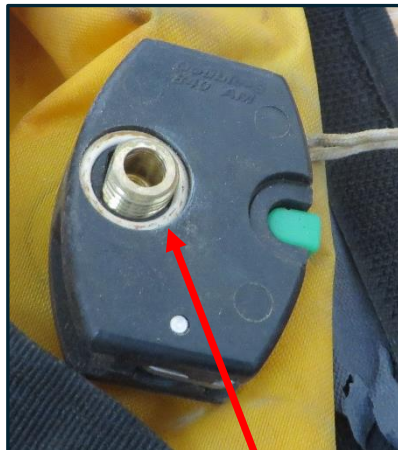
- One lifejacket had the retaining nut missing which secures the inflation device to the lifejacket (**Figure 6**);
- One Co2 gas cylinder was found to have been used but remained in place on the lifejacket. The lifejacket in question was deflated and packed in its cover (**Figure 7**);

Figure 6: Securing nut missing.

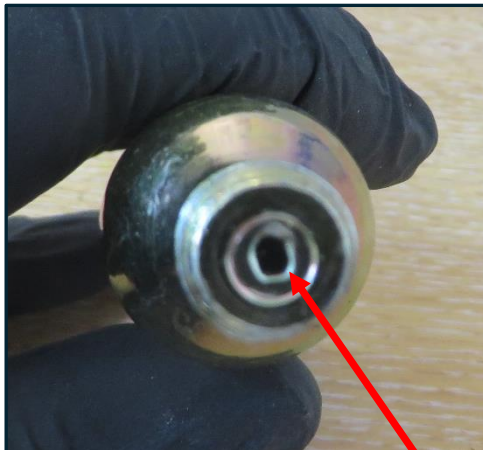
Figure 7: Co2 gas cylinder pierced (activated).

Any lifejacket onboard being used should be regularly serviced by a competent authority as per the manufacturers recommendations and the ship owners/operators should ensure that a maintenance program is in place on board the vessel to confirm that lifejackets are inspected on a regular basis.

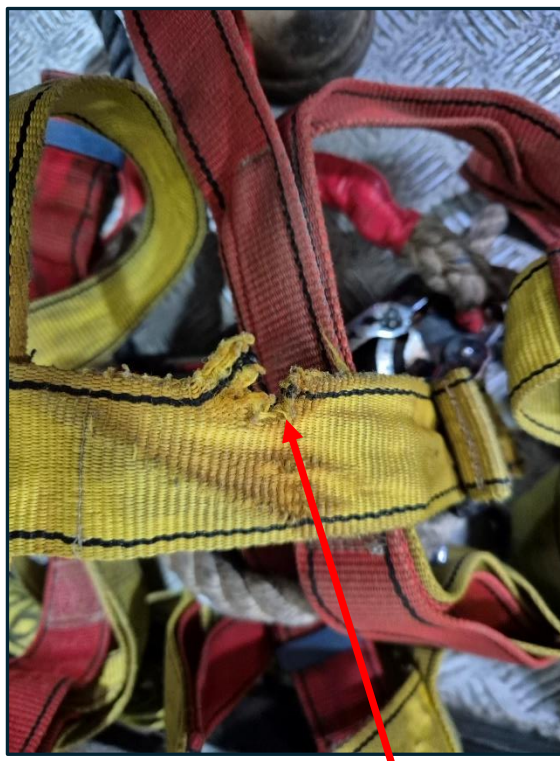
The investigation further found that some of the harnesses used onboard were not in a serviceable state. A Port State Control inspection by the Falkland Islands Maritime Authority after the accident identified that at least 5 harnesses were in a poor condition with rips in the webbing strap and stitching coming loose (**Figure 8**).

Figure 8: Safety harness showing rip in webbing.

- Prior to being identified during the investigation the local licence holder conducted a check of the vessel after the accident and replaced all non-compliant lifejackets with new lifejackets and a thorough check of these new lifejackets was made before they were issued to crew members. All safety harnesses were also checked and those found defective, were removed from service.

All crew issued with safety harnesses should have received safety training to ensure they are familiar with how to correctly put on a harness and understand where the safety line of the harness should be secured to on the ship.
