Report into the Grounding of fishing vessel

'An Fong 168'

Stanley Harbour, Falkland Islands
5th February 2025

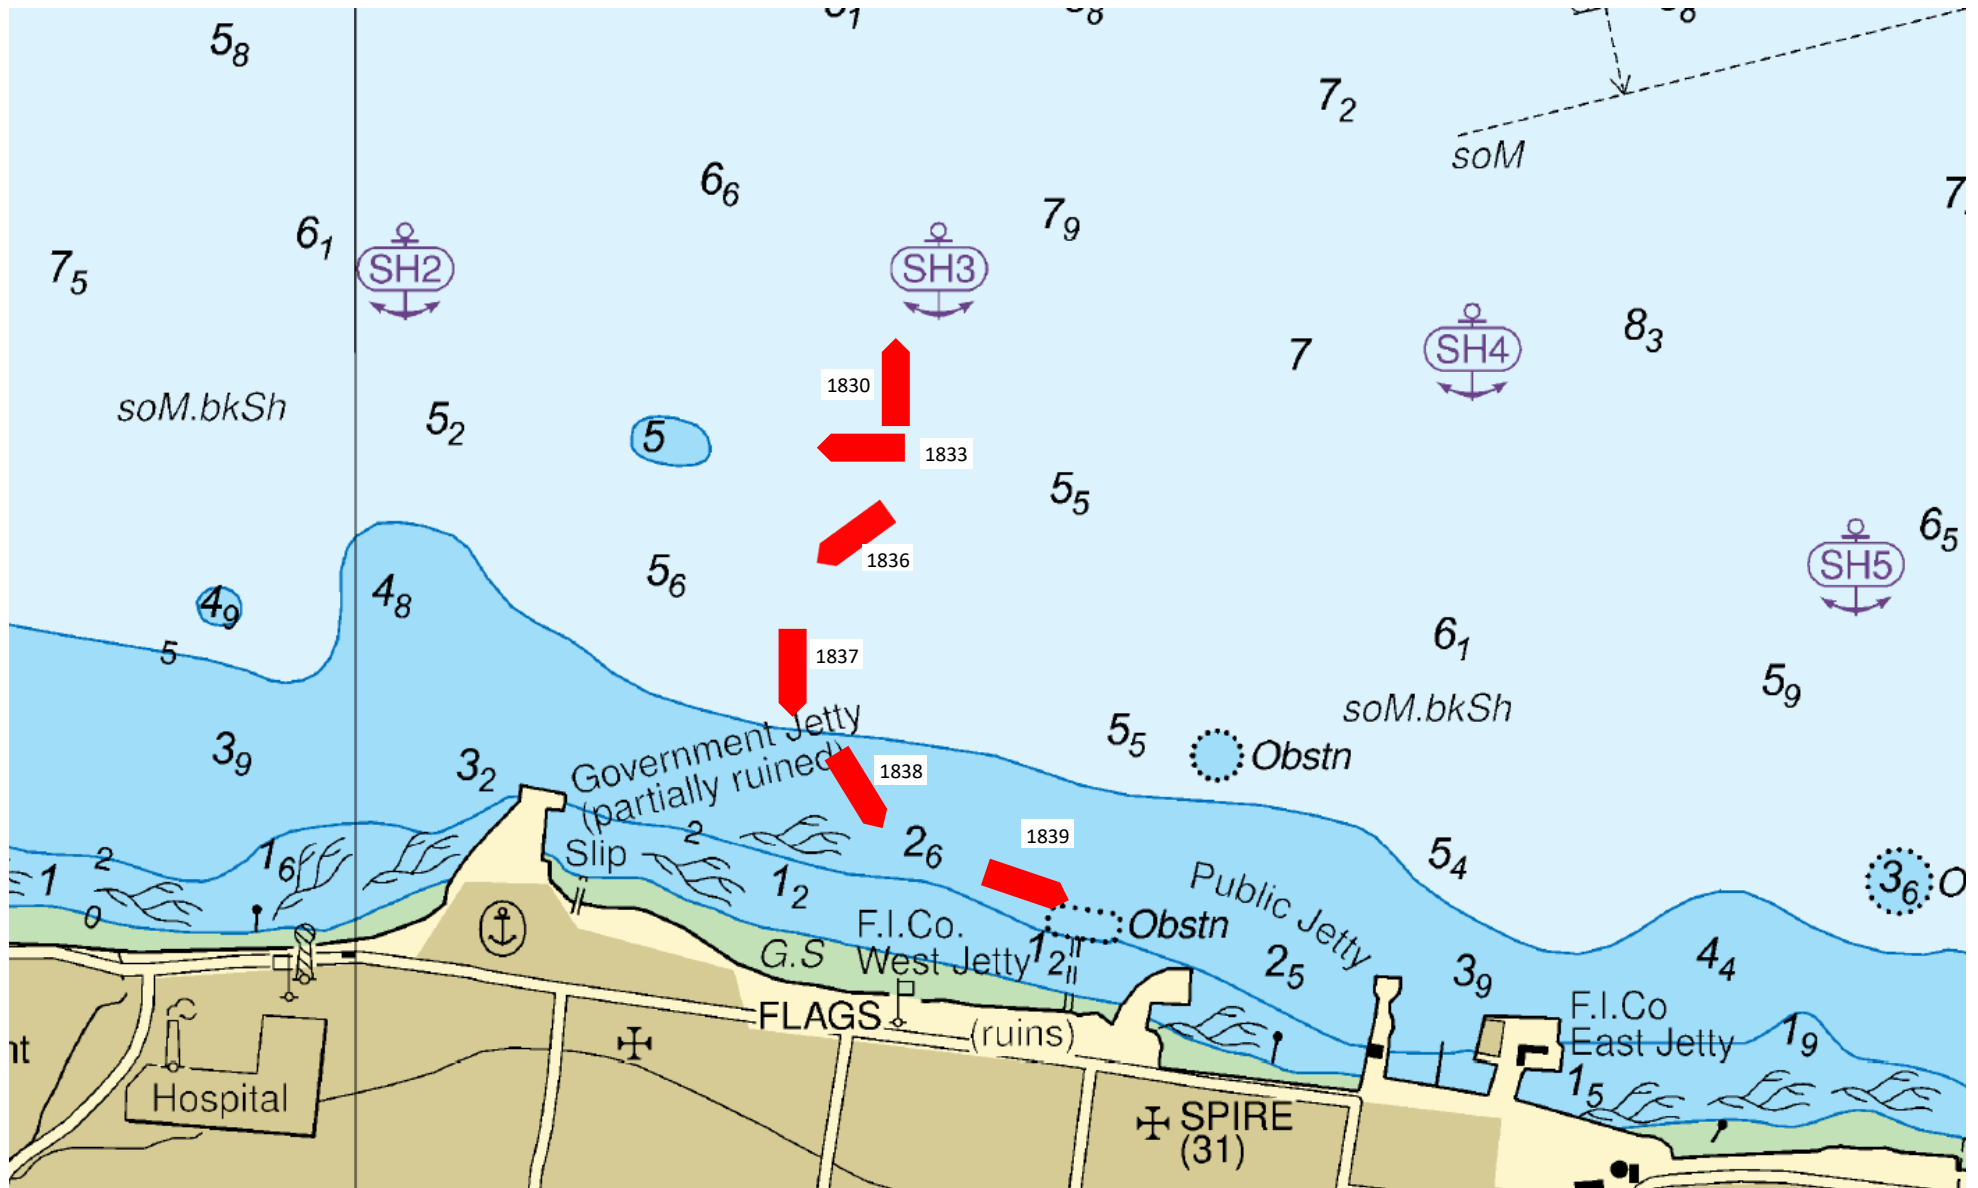
Figure 4: Positioning of An Fong 168 prior to grounding (NOT TO SCAL)

When the anchor was fully recovered, the master was aware that the vessel was rapidly drifting to the south shore, he applied starboard helm but stated this had no effect to the vessels heading, he then applied port helm to try and turn the vessel through 180° before the vessel grounded on the south bank of Stanley Harbour (**Figure 4**).

As the vessel started to heave the anchor, the wind swung the vessel to a westerly heading placing the wind on the starboard beam. The vessel continued to heave the anchor and the master stated that he applied starboard helm with the engine ahead to try to move the vessel to starboard to place the bow into the wind, but this had little effect, so the master applied port helm to turn the vessel to the South with the intending of completing a 180° turn to port.

As the anchor continued to be retrieved the vessel gained momentum in a southerly direction as a result of the wind and the engines moving ahead with port helm applied. At approximately 1838, the vessel passed over the 5m depth contour on a SSW heading bringing the vessel into shallow waters. The vessel was unable to complete its turn and ran aground on the wreck of the Charles Cooper. CCTV footage from the vessel shows the heading of the vessel prior to the grounding (**Figures 7,8 & 9**)

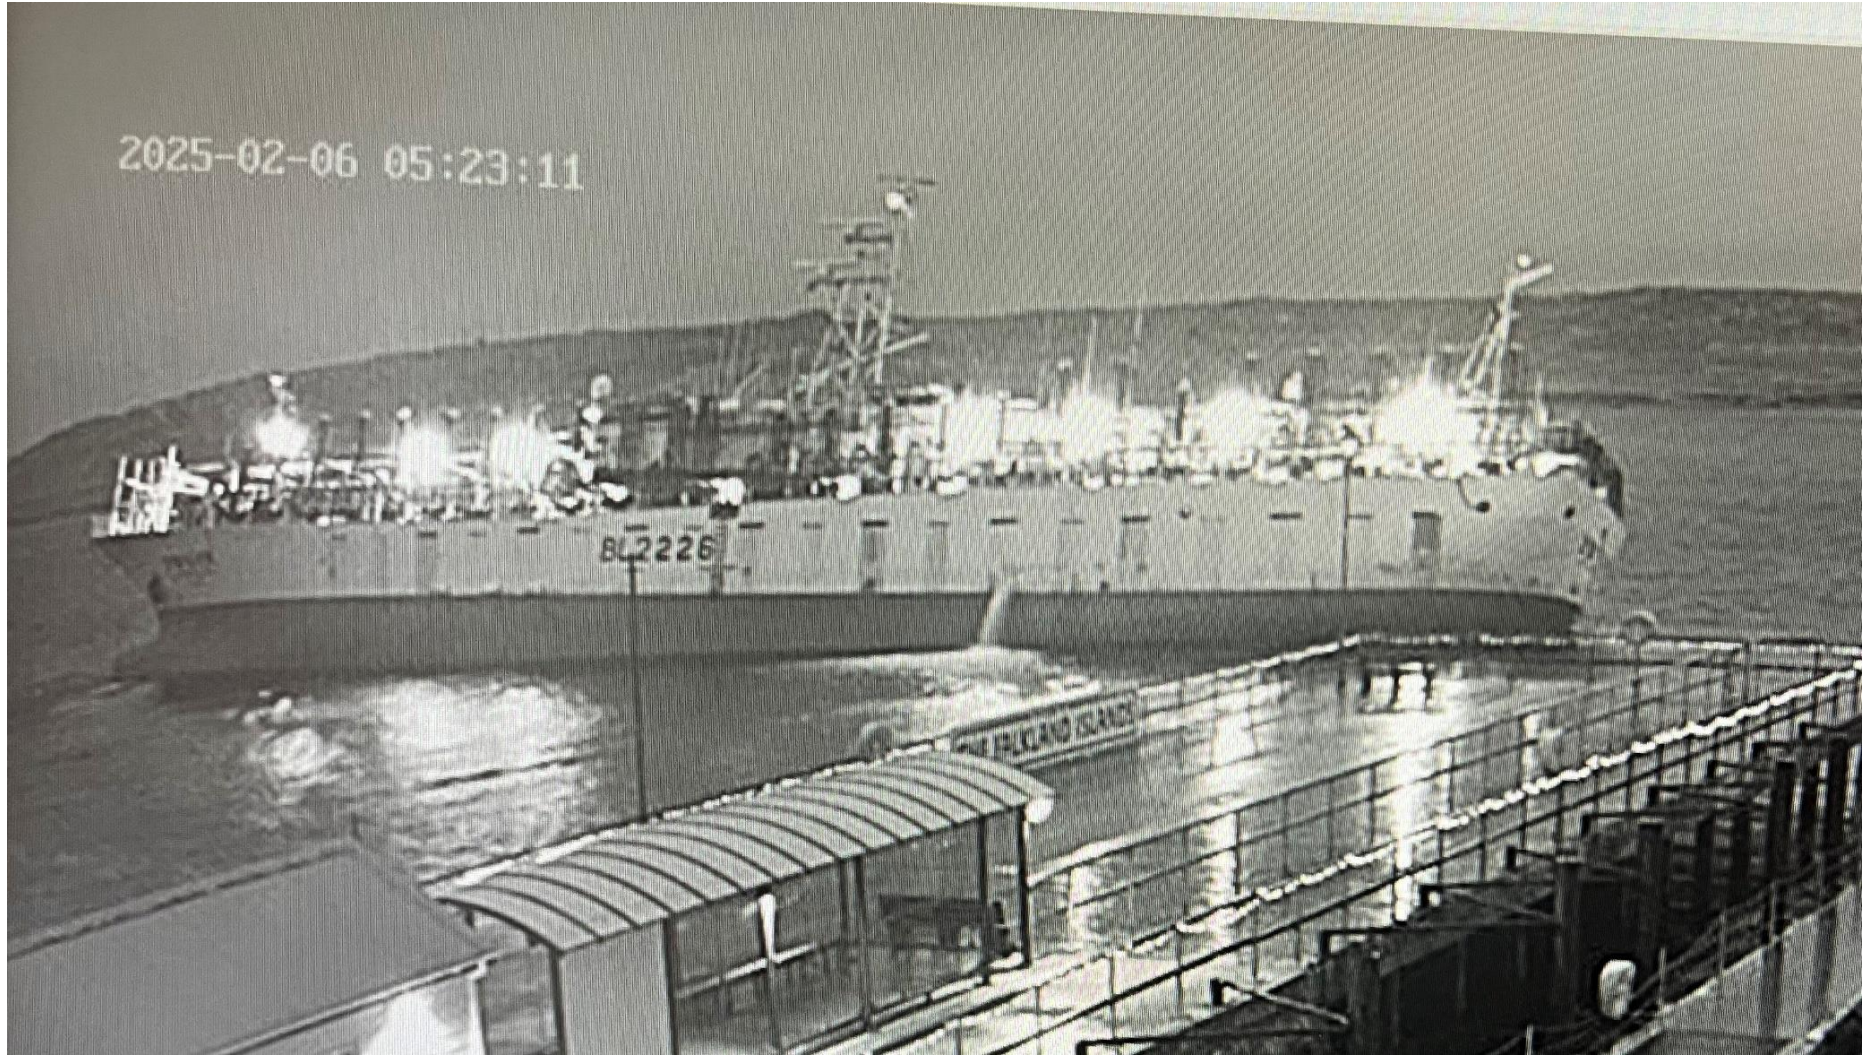
Figure 6: Web cam footage from the SURE web cam on the visitor's jetty center.

Throughout the evening FIMA conducted hourly rounds to the public jetty to check on the condition of the vessel and any signs of pollution. FIMA were also able to observe the vessel via a webcam provided by SURE which is positioned on the visitor's jetty centre which gave a clear image of the grounded vessel (**Figure 6**)

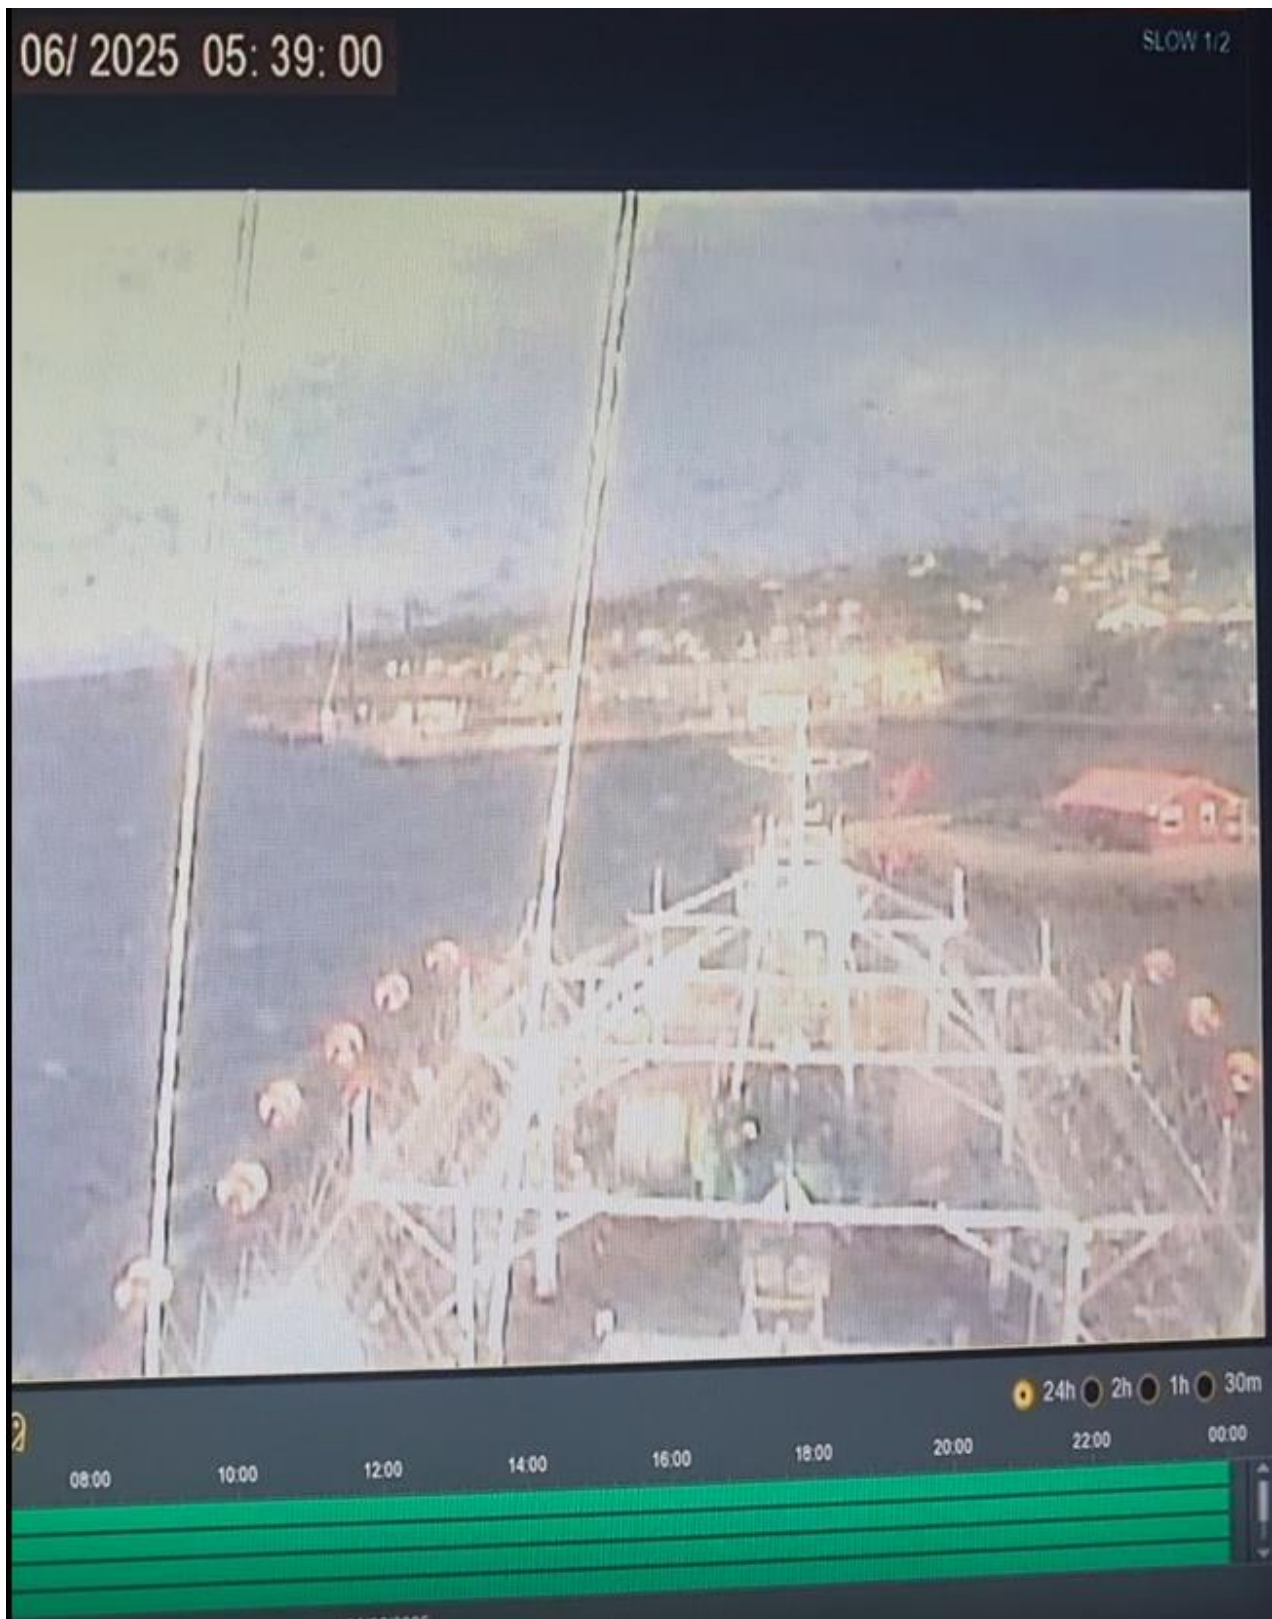
Figure 9: CCTV Footage looking forward with the vessel aground

1839 Vessel aground. On-board Closed-Circuit Television cameras (CCTV) show that the vessel came to rest close to the wreck of the Charles Cooper⁸ 9 minutes after the master identified that the heading of the vessel was moving when heaving up the anchor. The Master of the *An Fong 168* called the local representative in Stanley to inform them of the situation. The master continued to run the engine using astern propulsion in the hope that he could free the vessel, but this had no effect.

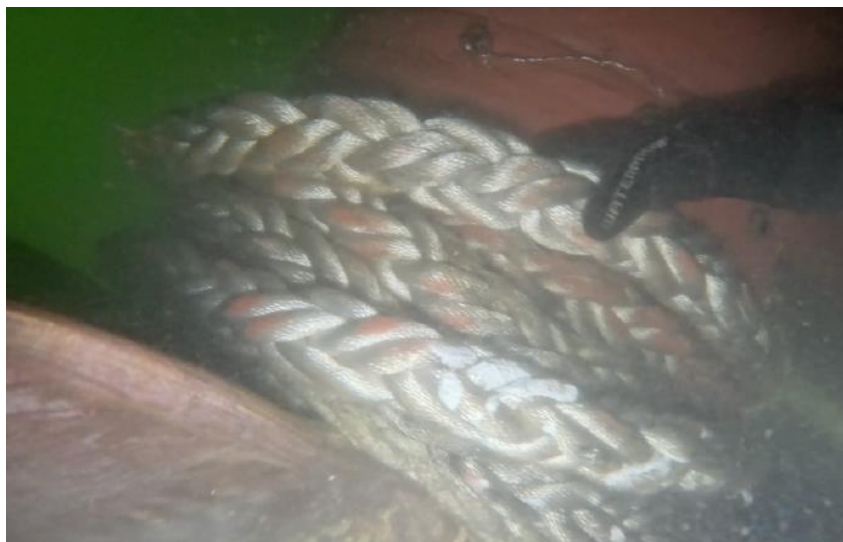
Figure 10: Fouled propeller

The *Fitzroy* released the line attached to the *An Fong 168* and started to back away in to clear water and away from the vessel. When the tow line was released from the *Fitzroy* it started to sink beneath the surface. The crew from the *An Fong 168* started to heave the line and were unaware that the line had sunk. The master engaged astern propulsion to move his vessel further astern, this action caused the remaining tow line in the water to be pulled towards the propellor which caused the propellor to become fouled.

The inspection found that the propeller was fouled with a number of turns of the polypropylene mooring line used for the tow. This line was wrapped around the propeller shaft with most of the line trailing on the seabed (**figure 10**).

The translator passed the message from the launch to the master on the *An Fong 168* and the master acknowledged the message, moments after the tow line was released the *An Fong 168* started its propulsion without checking if the line had been recovered from the water. This action caused the propeller to foul and the vessel to be disabled.

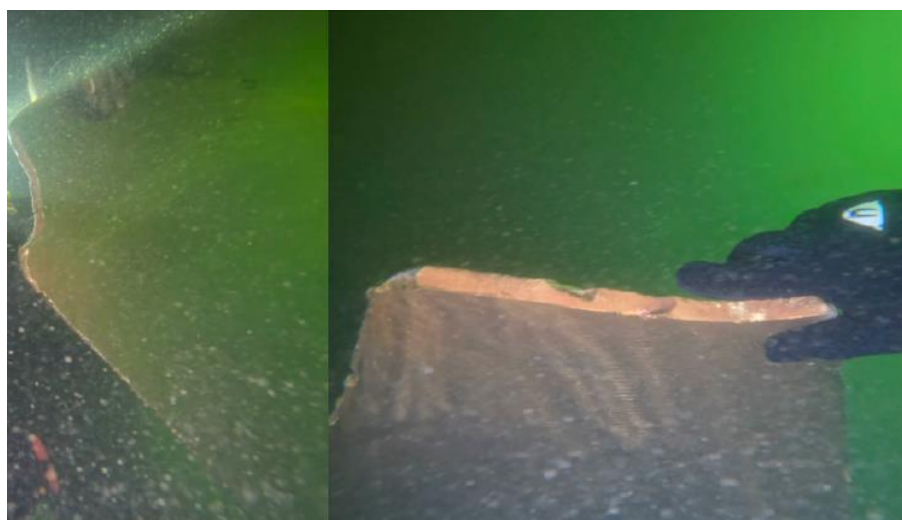
Figure 11: Damaged propeller blade

The Master of the *An Fong 168* became aware of the fouled propellor when this was reported to him by a crew member on the aft mooring station. With the vessel disabled, it drifted bodily towards the head of the Public jetty, No attempt was made to drop the anchor from the *An Fong 168* as it was deemed this would have little affect and would have caused the stern to swing to the South possibly causing damage to the propellor and rudder.

The propeller showed signs of heavy damage to the leading edge of the propeller with large pieces missing, metal tearing and bending of the edge of all four blades (**figure11**).
