Report into the Grounding of:

**EUN HAE 107**

Port Egmont, Falkland Islands  
10 February 2025

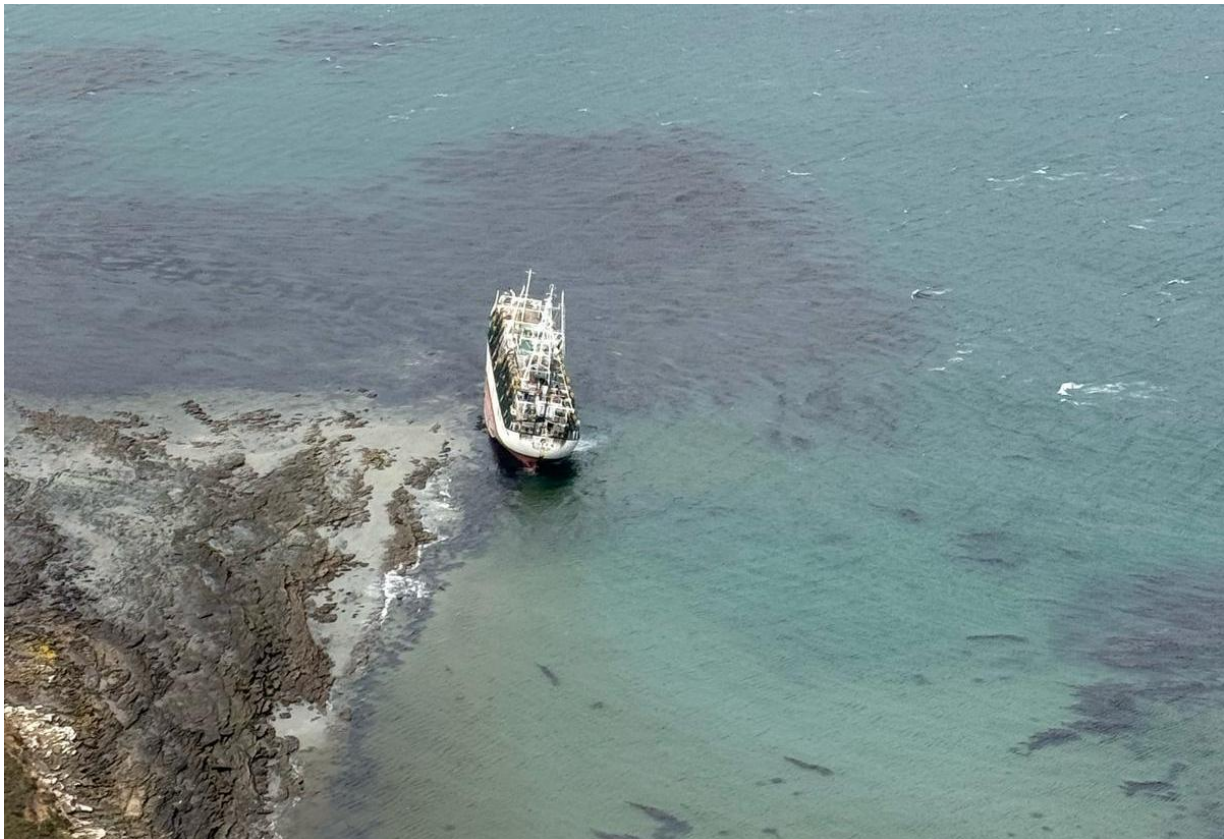
*Figure 1: FV Eun Hae 107 in Port Egmont*

At 1645LT<sup>1</sup> on 10 February 2025, the Korean-registered jigger fishing vessel *Eun Hae 107* ran aground (Figure 1) south of East Point in Port Egmont, Falkland Islands. The vessel was taking shelter in Port Egmont due to forecast heavy weather conditions where gusting winds were expected to reach gale force 10<sup>2</sup>.

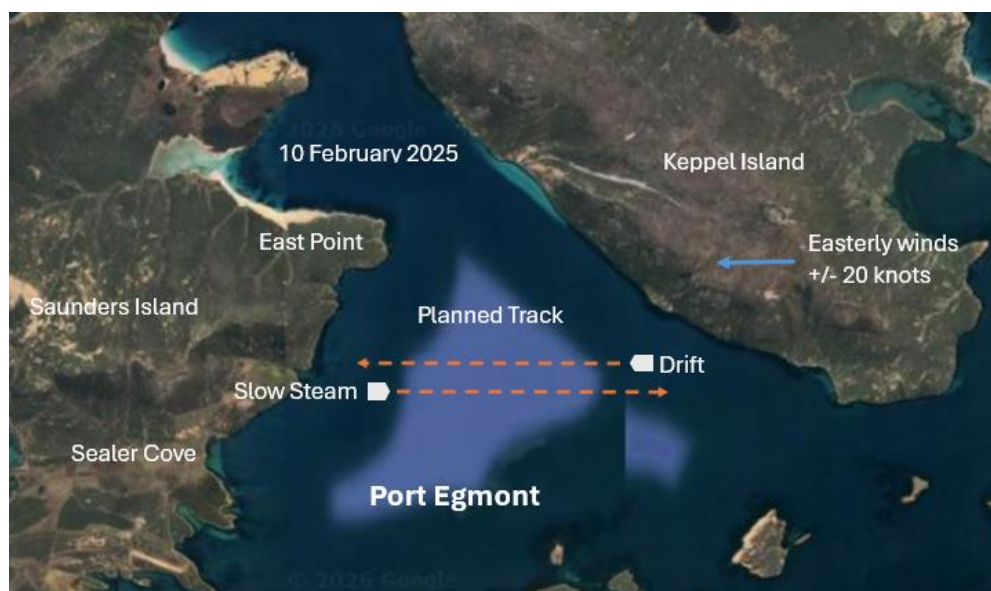
*Figure 8: On arrival, planned track to follow during sheltering*

When the vessel approached Port Egmont at 04:53 the Master called the bridge team to the wheelhouse. The bridge team consisted of the Master, Chief Officer and the Radio Officer who also kept navigational watches. The Master of the vessel instructs the bridge team that with the easterly winds, the vessel is to slow steam to the east of Port Egmont, no specific turning point is advised. When reaching eastern part of Port Egmont the vessel is to stop engine and allow a drift to the western part of Port Egmont. According to the Master's orders, a distance of 0.5NM should be kept from the nearest land at all times. No other navigation information is discussed, expected change in wind speeds or direction are not discussed, nor the effects of tides within the area. Consideration was not given to shallowing depths closer to prominent land points.

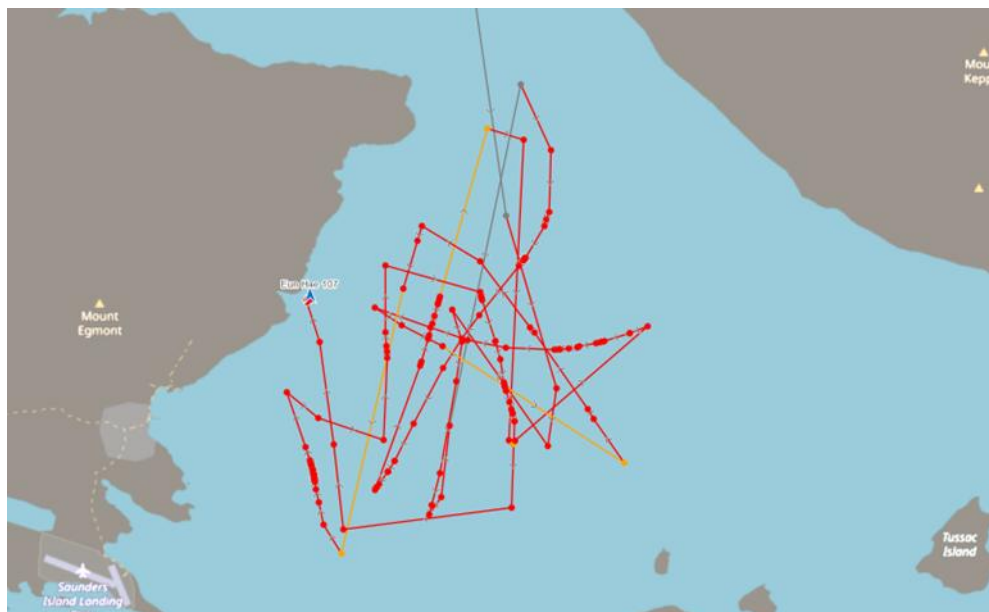
Figure 9: Actual track of the vessel in Port Egmont

Throughout the watch of the Chief Officer, AIS shows that the vessel maintained rough courses of 320° and 110°. This kept the easterly winds on the beam of the vessel. This meant the vessel had a westerly drift even during course changes between north and south that were not accounted for. At 1500 the Radio Officer took over the navigational watch from the Chief Officer.

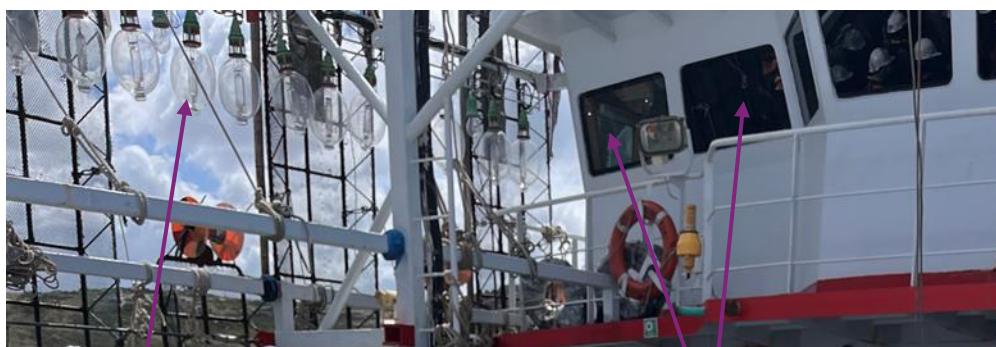
*Figure 10: Jigging Lights*

A jigging vessel is designed to fit jigging lights<sup>16</sup> on the exterior of the superstructure of the vessel as shown in figure 8 which provides an example of the lights in relation to the bridge windows. These lights are mounted along the vessel at wheelhouse level and are used during fishing operations. These lights were not in use during the time the vessel was taking shelter. When one looks outside the windows in the wheelhouse as seen in Figure 9, the lights are at bridge window level which complicates the view out of the wheelhouse window. Extra consideration should be given to the presence of these lights given the sea spray, rain and general weather conditions that impacted the OOW’s visibility when maintaining lookout through the wheelhouse windows.

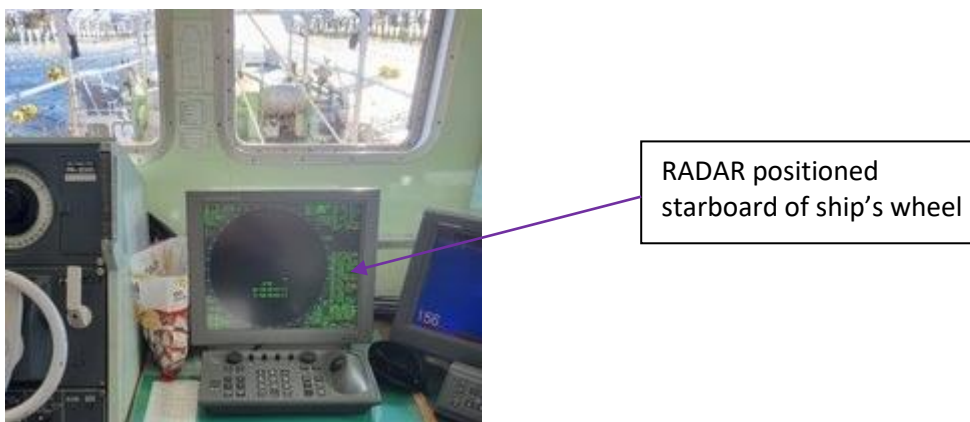
*Figure 13: RADAR*

The cursors on the radars were used by the watchkeeper to measure the distance between the vessel and the most prominent land (and the minimum distance to keep was 0.5NM). The radars are fitted with Variable Range Markers (VRM) and Electronic Bearing Lines (EBL) which can be used to measure distances and bearings of objects in relation to the vessel.

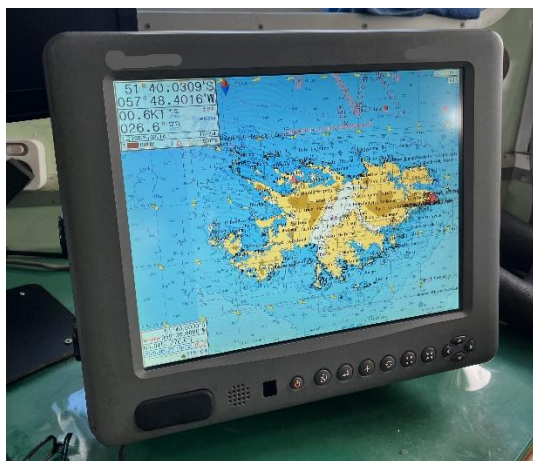
*Figure 14: Electronic Chart System (ECS)*

The distinction between ECS and ECDIS lies in regulatory and legal compliance. ECDIS complies with SOLAS regulations and is legally recognized as a complete replacement for paper charts or supplement to paper charts if vessel is not in compliance with all the requirements for complete replacement of paper charts using ECDIS. In contrast, ECS is intended as a supplementary navigation aid, does not meet these regulatory standards, and must be used alongside official paper charts which must be kept up to date. If the ECS is to serve the same purpose as ECDIS, for a vessel built before 1999 the system installed would need to comply with the performance standards as prescribed in IMO Resolution A.817(19).

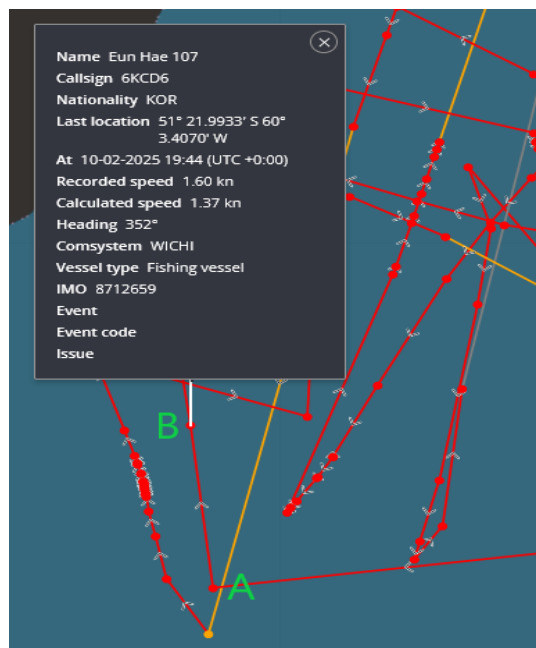
Figure 15: Vessel Position B

When the engine had been placed on slow ahead, a certain amount of time is needed to allow the vessel to gain substantial speed to affect the steering commands. On the *FV Eun Hae 107*, it takes 14 seconds for the engine to respond when placed slow ahead and 17 seconds when placed slow astern. From this time the vessel will start gaining speed. This information was calculated during sea trials, as provided by the vessel owner. The response of the engine is expected to be different when other factors influence the vessel response. Factors such as wind, current, how much the vessel is loaded will also influence the response time of the vessel to gain significant momentum to avoid danger. No engine or steering issues were reported, which could have had an effect on the manoeuvrability of the vessel. The engine and steering capabilities performed as expected throughout.

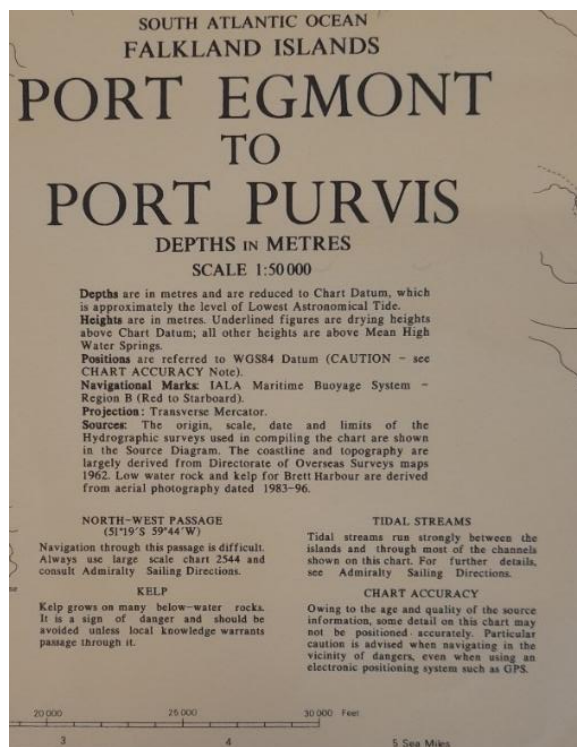
Figure 17: Admiralty Chart 2545 note

an approved ECDIS, the CATZOC rating will appear on the chart display to bring to the attention of the navigator where the vessel is in an area of poor depth accuracy where there is an increased risk of unidentified dangers. This warning or information was not found on the ECS used on the *FV Eun Hae 107*.
