# Report into the Grounding of the reefer

## **'Frio Chikuma'**

Port William, Falkland Islands  
3<sup>rd</sup> April 2024

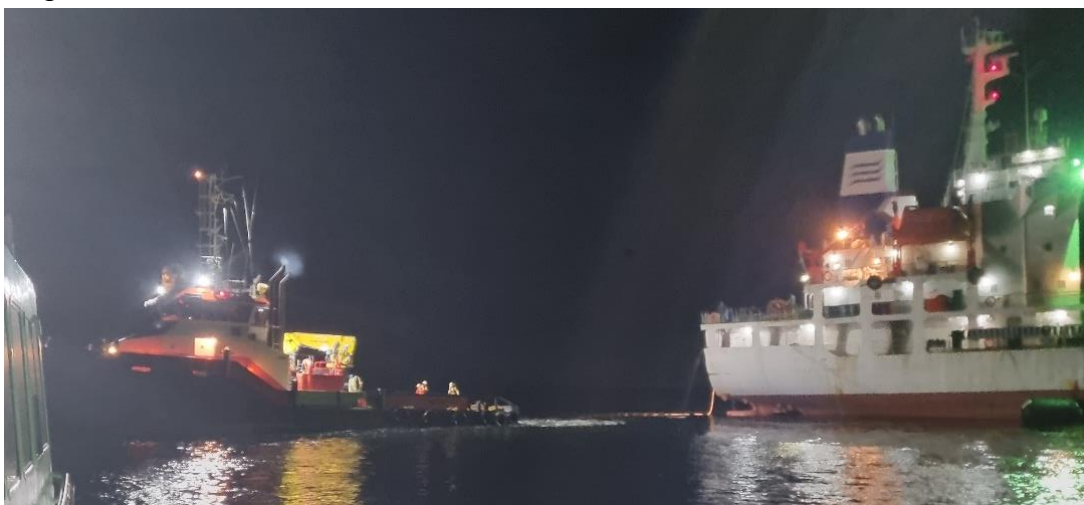
**Figure 7:** Tug establishes towline with *Frio Chikuma*

Another concern was the expected wind conditions which, although they had abated during the day, were due to increase after midnight from the North around the planned time for the refloat. It was agreed that the refloat would take place at the high tide on the morning of 4<sup>th</sup> April. The tow line was established at 2340 on the 3<sup>rd</sup> April (**Figure 7**) in good time before high water. At around 0100 weight was applied to the tug's tow line and the vessel was reported to be afloat at 0110 where she was towed back to her anchorage.

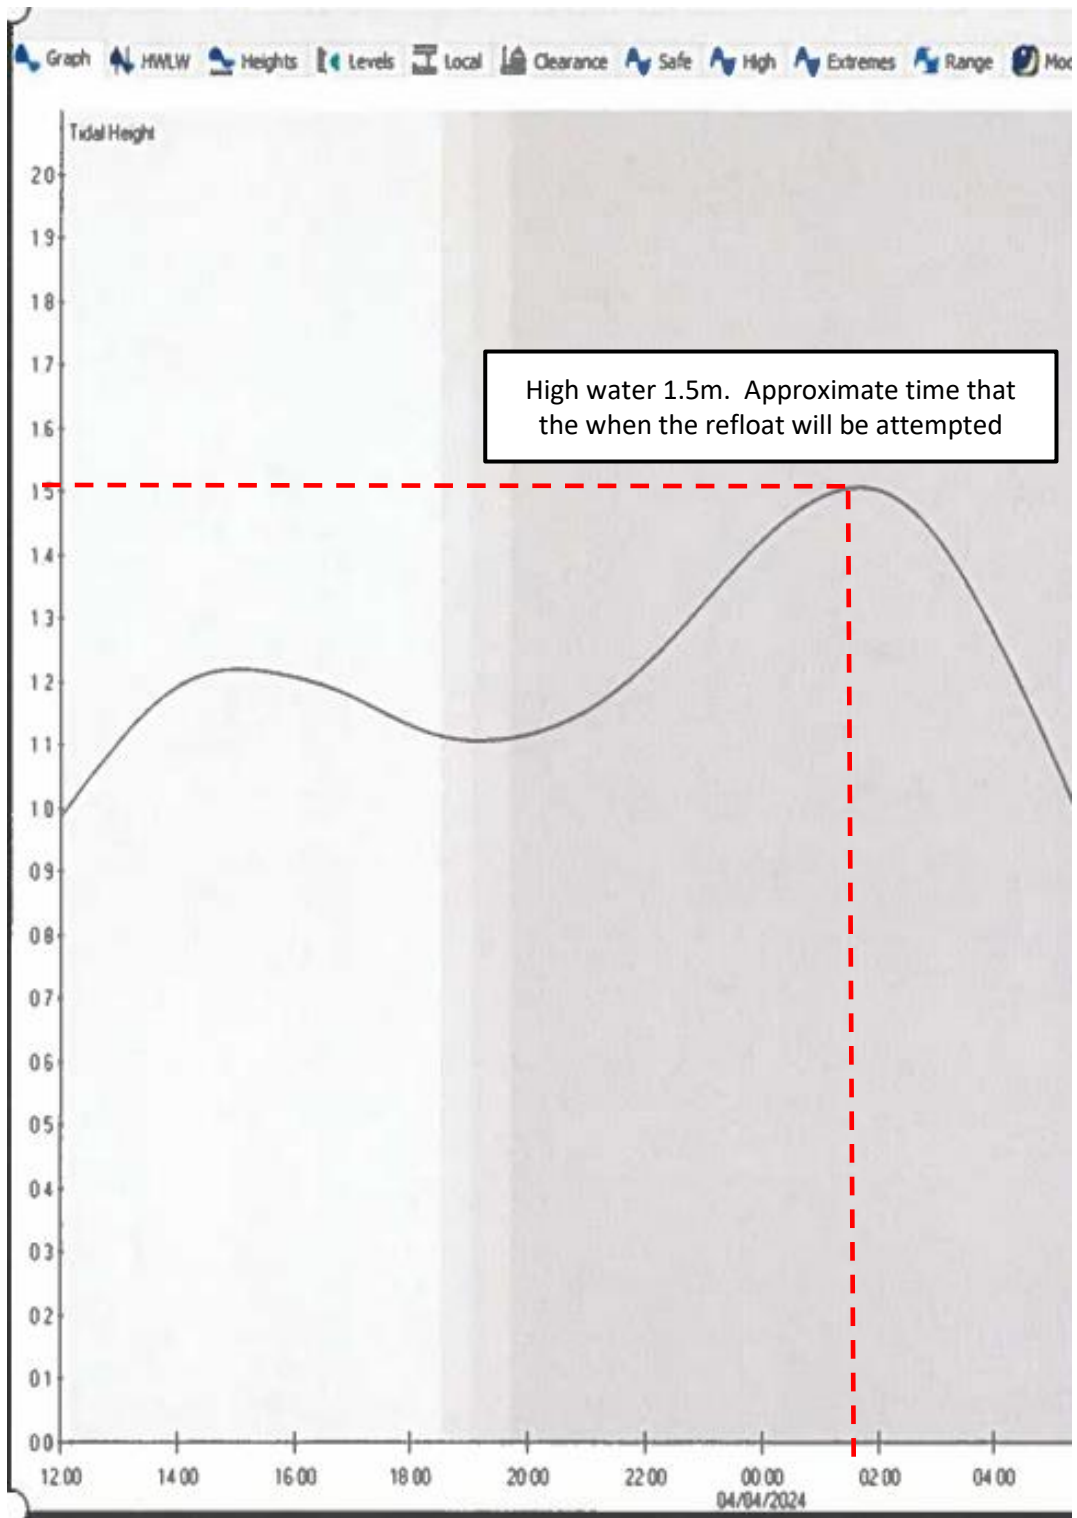
**Figure 8:** Extract from Admiralty Tide tables showing height of tide and times on 4<sup>th</sup> April 2024

Once information had been received regarding the seabed where the *Frio Chikuma* had grounded, the tides were reviewed and it was decided that an attempt to refloat would be made in the early hours on 4<sup>th</sup> April. Due to the mixed semi-diurnal tides experienced in the Falkland Islands, the next high water would be just before 1500 on 3<sup>rd</sup> April but the height of tide would only be 1.21m which would be 20cm lower than the height of tide when the vessel ran aground (**Figure 8**). It was agreed that the afternoon tide would be no good for a refloat attempt. There was a slight concern that the height of high water when the refloat attempt would be made (in the early hours of the morning on 4<sup>th</sup> April), was going to be 10cm lower than when the vessel went aground (**Figure 9**). An option would be to wait for the next high tide which would have been higher, however the next low water would have been lower which could have caused damage to the vessel.

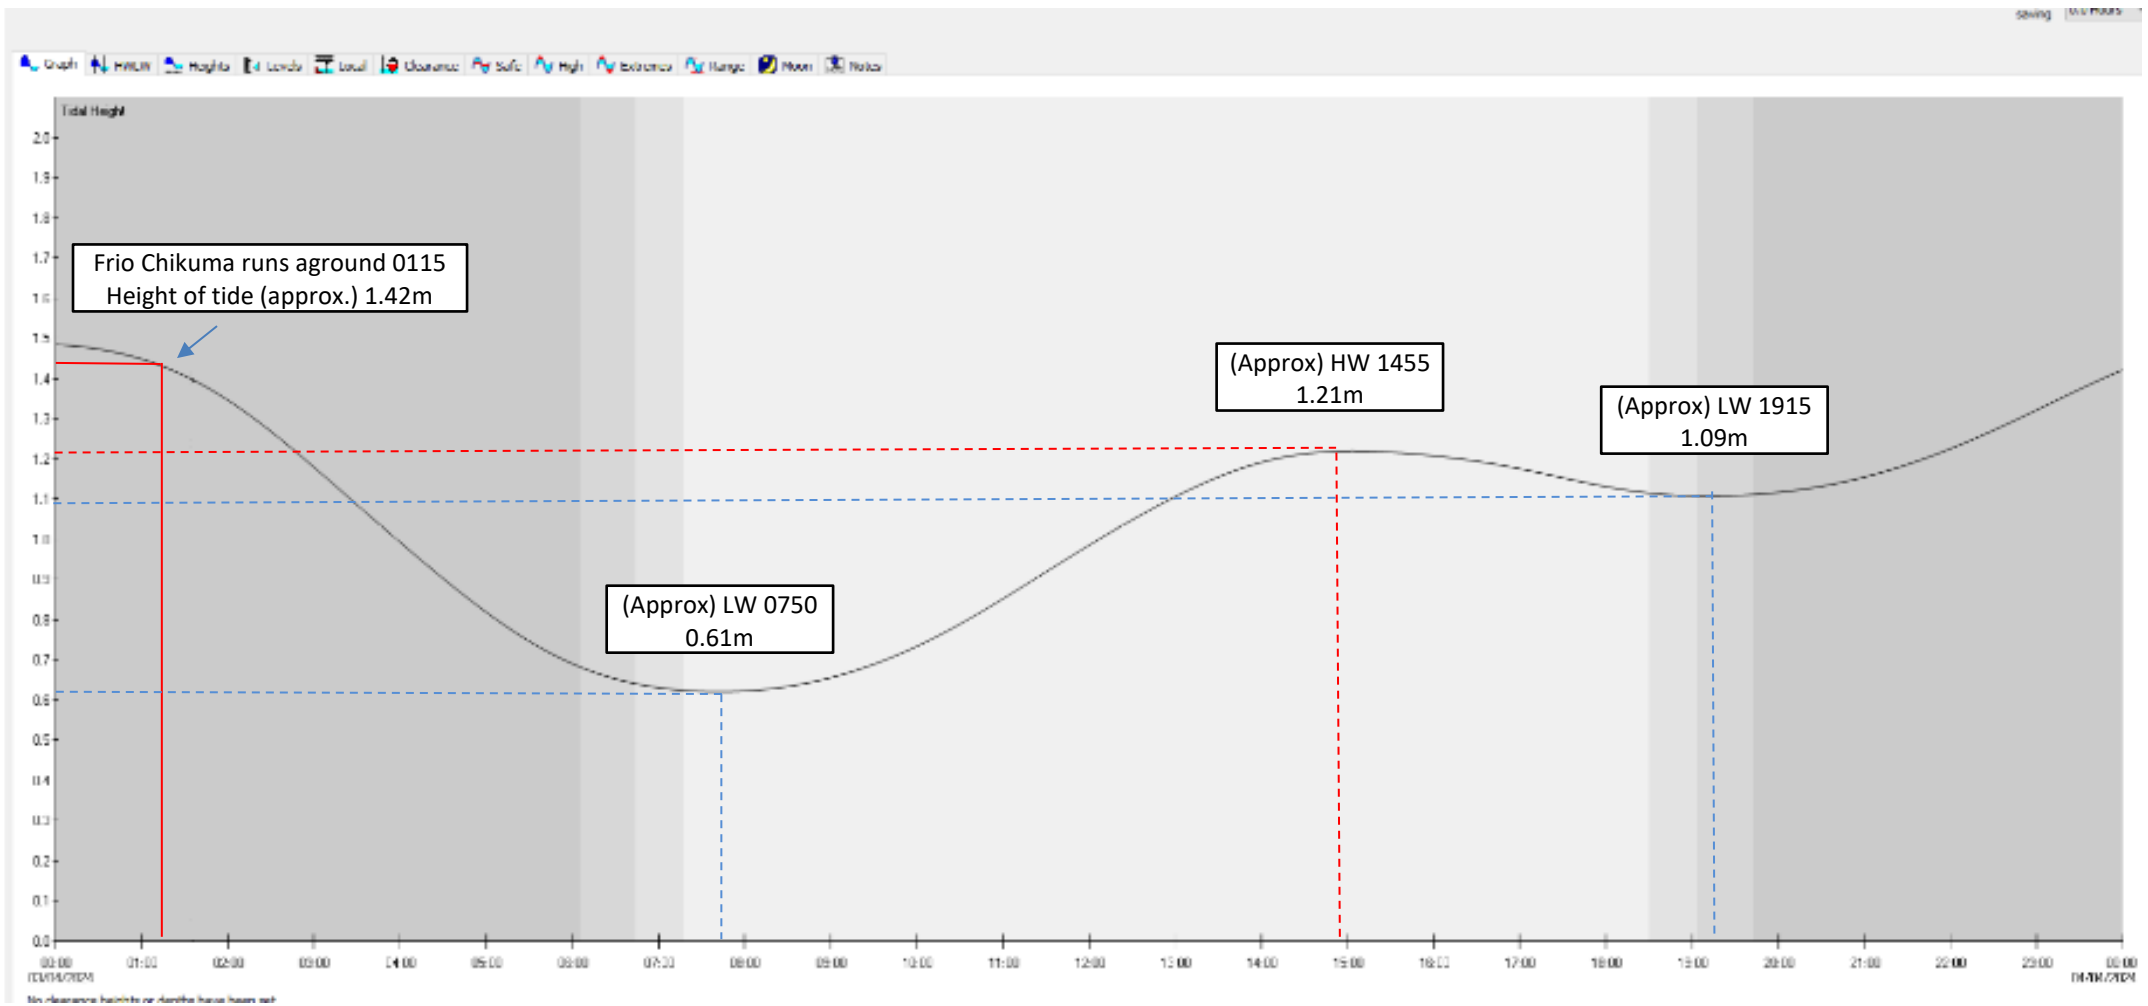
Figure 9: Extract from Admiralty Tide Tables showing approximate height of tides on 3<sup>rd</sup> April 2024

At 0125, the HM arrived at the FIMA ops room and was updated on the situation. The tidal information was checked at this point, and it was noted that the current height of tide was at 1.4m and falling with low water expected just before 0740 at 0.6m. The tidal graph was printed out and an incident board was started.
