Report into the Grounding of fishing vessel

'An Fong 168'

Stanley Harbour, Falkland Islands
5th February 2025

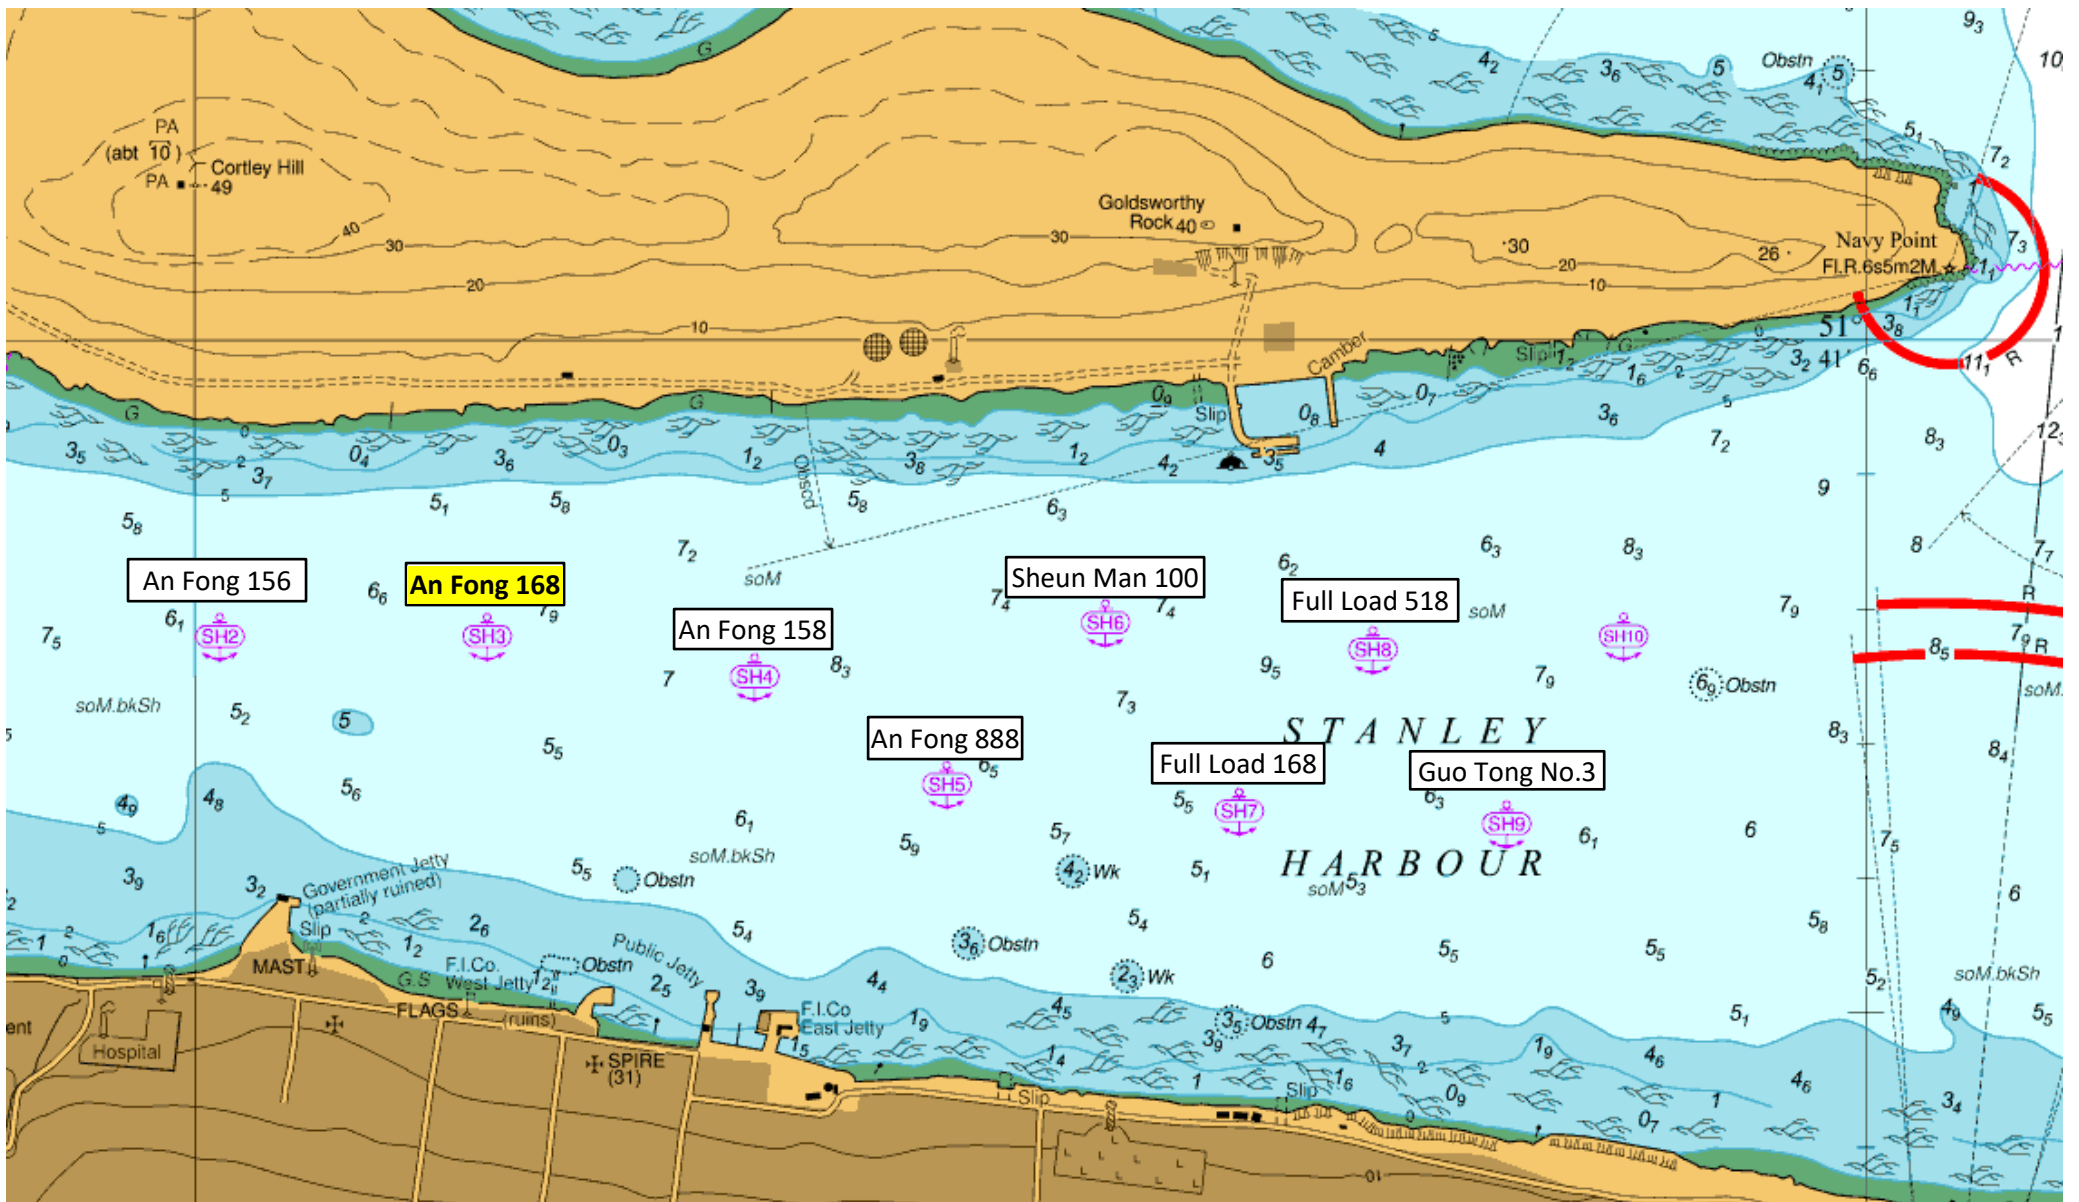
Figure 1: Stanley Harbour anchorages overview

1015 Local time (UTC -3) on the morning of 5th February 2025, *An Fong 168* crossed the Port William reporting line, after her sea passage from Kaohsiung, Taiwan and passed her entry information to Stanley Port Control¹ by Very High Frequency (VHF) radio on Channel (Ch) 10. The vessel then proceeded to her allocated anchorage at Stanley Harbour (SH) 3 and let go her Starboard anchor to 4 shackles² in the water. At the time of her arrival at the anchorage, Stanley Harbour had seven other jiggers who had already been at anchor since around 0700 that morning (**Figure 1**).

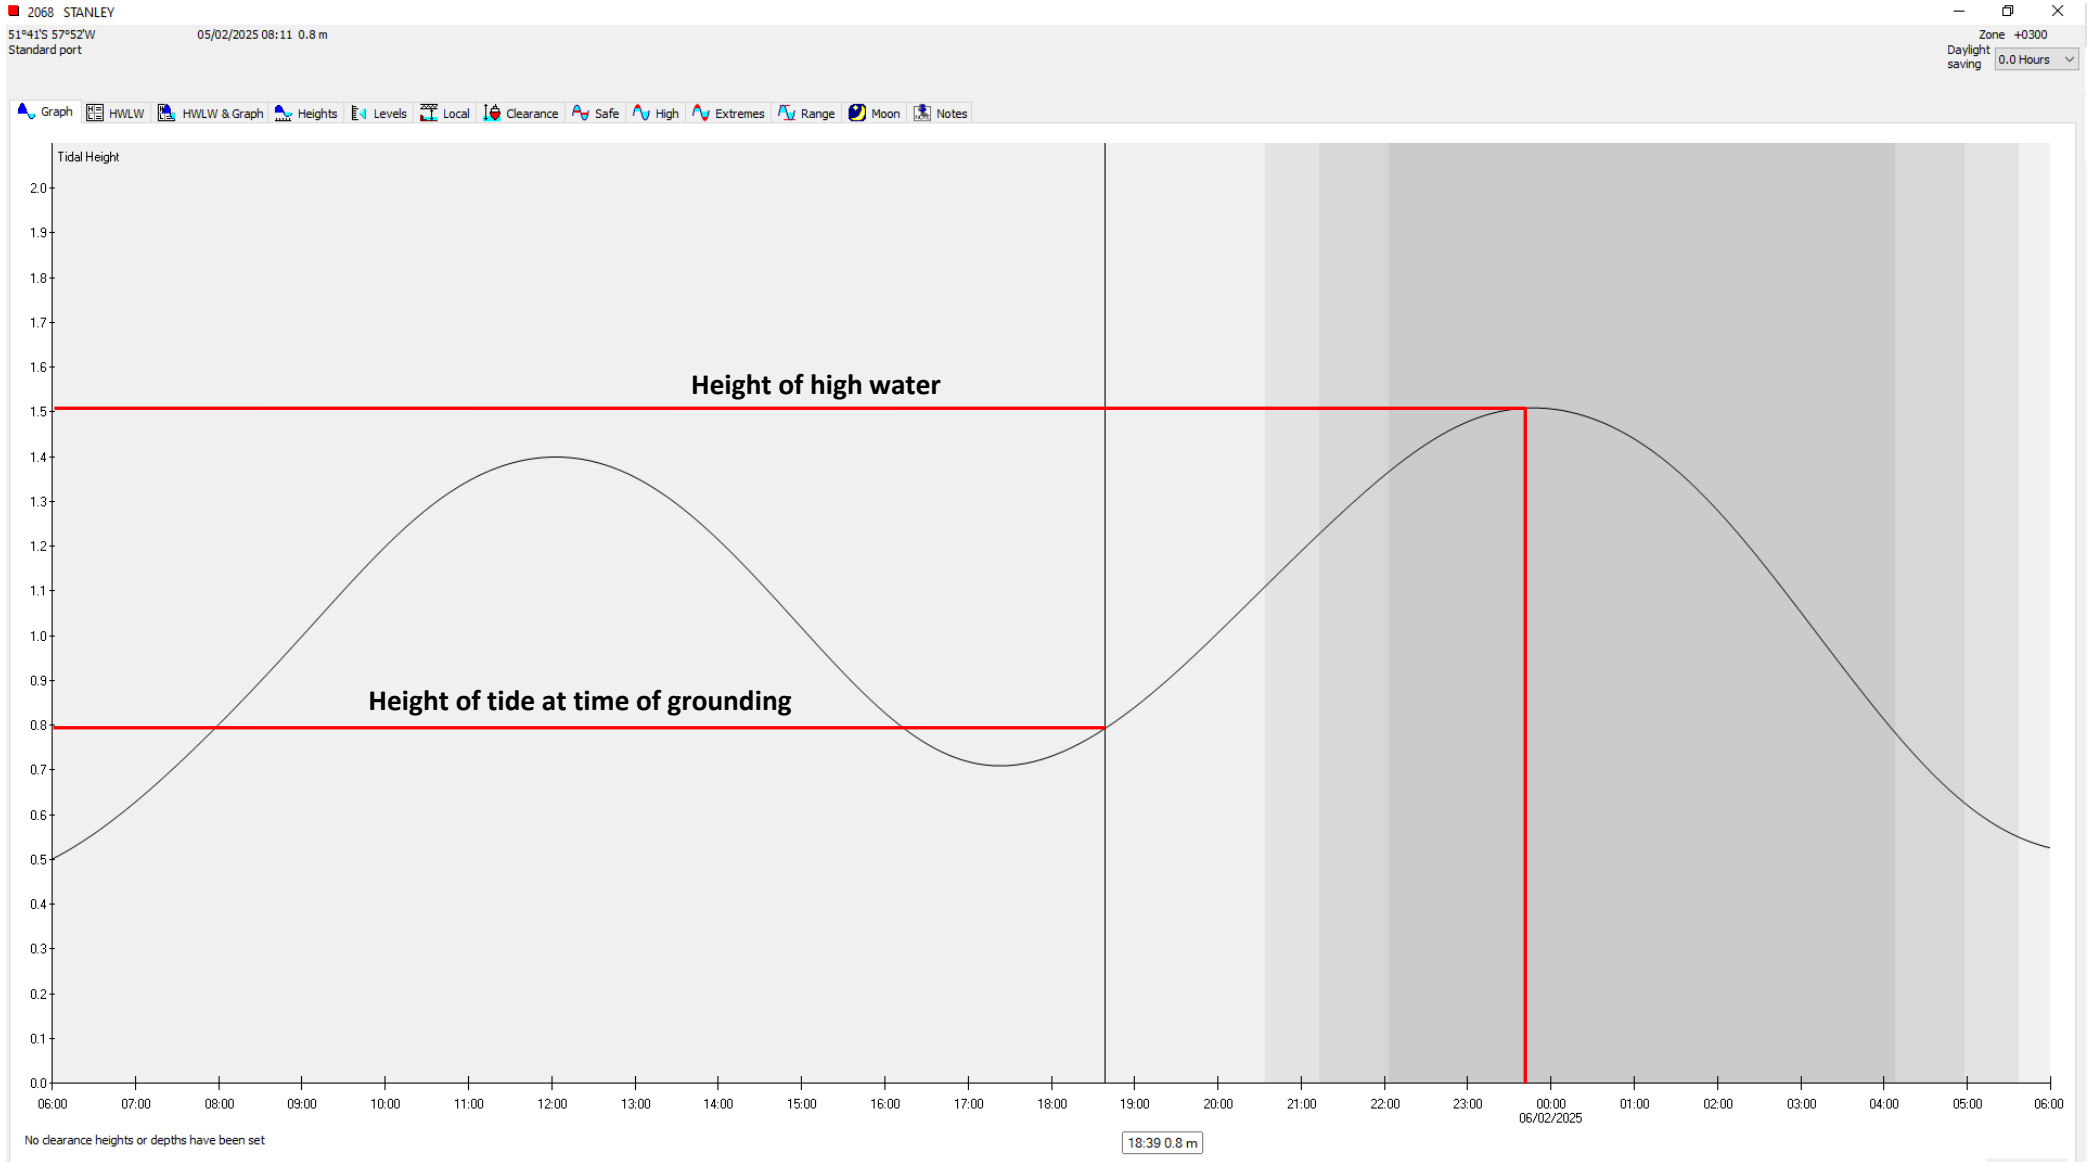
Figure 5: Extract from Admiralty Total Tides, showing Height of tide at the time of the grounding.

At 1852 FIMA contacted Sullivan Shipping launch company and requested all available launches to proceed to the jigger to assist with refloating the vessel. The tides were assessed and found to be at 0.8meters (m) on a rising tide with high tide expected to be 1.5m at 2347 (**Figure 5**).
