Report into the Grounding of:

**EUN HAE 107**

Port Egmont, Falkland Islands  
10 February 2025

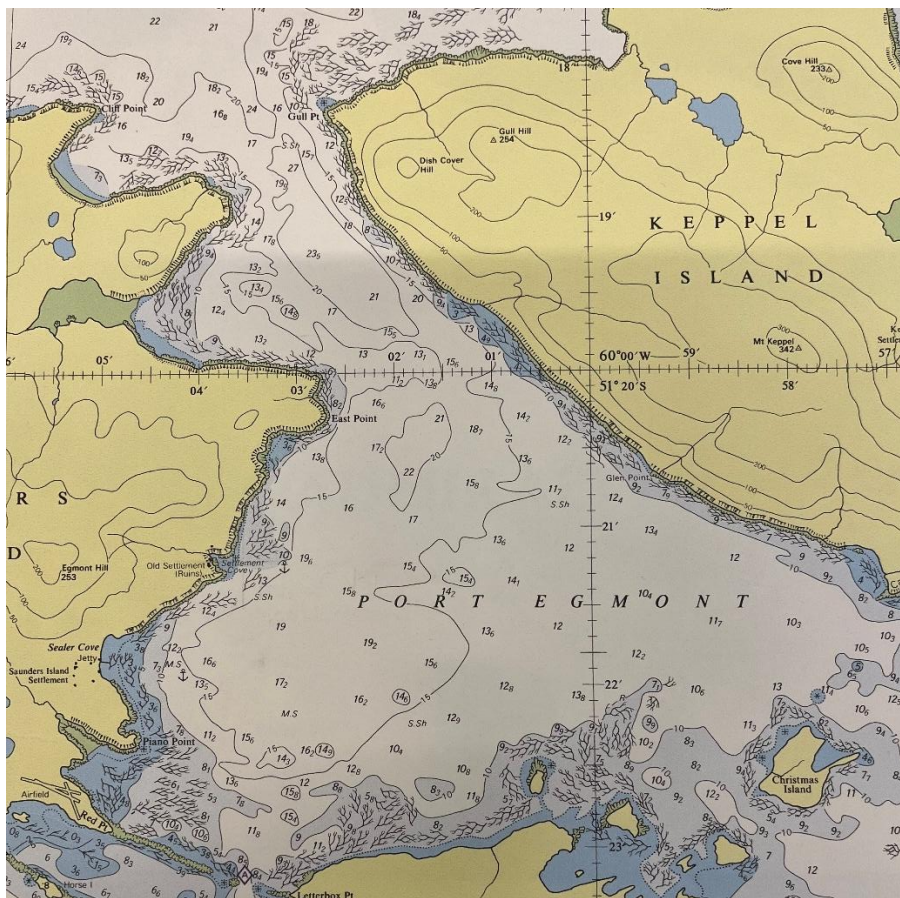
Figure 4: Port Egmont Chart 2545

1645 In accordance with the logbook entries, the vessel was recorded to have aground in position 51°21.2'S 060°03.6'W. Nearest land according to the Admiralty chart 2545 is 0.12NM. Recorded weather conditions by the vessel:

When it was within Port Egmont the vessel was not at anchor. According to the admiralty chart 2545 edition 6<sup>24</sup> as issued by the UK Hydrographic Office, shows the deepest depth is 19.6m. It should be noted that a note is published on the chart to advise that detail on this chart may not be accurate given the age and quality of survey information. The choice opted for by the vessel in taking shelter in Port Egmont was to drift and engage engine to steam away from danger when needed. Information provided by the bridge movement book shows that the engine was used more frequently than compared to the initial sheltering plan when the vessel had entered Port Egmont.

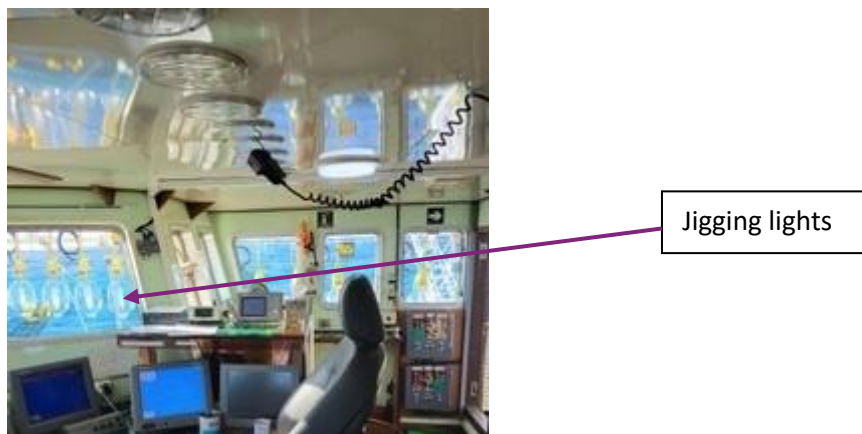
Figure 11: View from inside the wheelhouse looking out

sunset on that day was at 2028<sup>18</sup>. Even if there was light on the shoreline, this would not have contributed to the vessel grounding as there was still sufficient daylight. Light on the deck forward of the bridge would not have had an effect either where back scatter of deck light might have caused the OOW not to see the shoreline during hours of darkness.

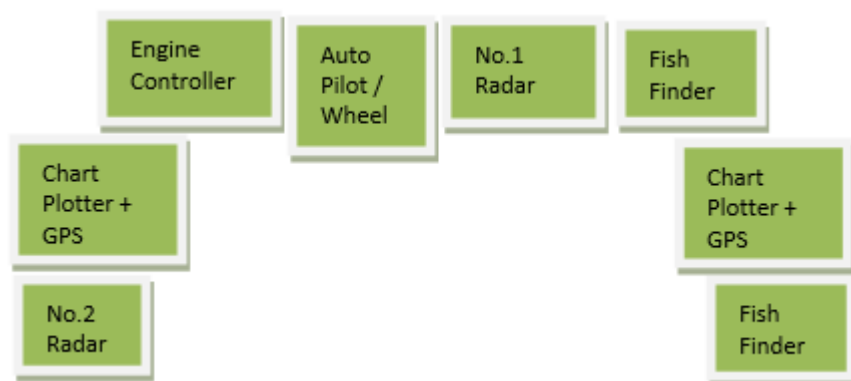
Figure 12: Wheelhouse Layout

*FV Eun Hae 107* is fitted with equipment needed to provide sufficient situational awareness of the surrounding area. Other equipment includes rudder angle indicator, anemometer, magnetic compass, gyro compass, AIS and GMDSS<sup>17</sup> equipment. At the time that the investigation was carried out onboard the vessel, all bridge equipment was operational upon testing, and no malfunctioning of equipment was reported to have occurred when the vessel went aground. There were no reports of other machinery failures such as failure of the steering gear or the vessel's main engine as examples. All equipment and machinery were working as expected leading up to the grounding of the vessel.

Fitted on the bridge with two Electronic Chart Systems (ECS), example of equipment given in Figure 12. The ECSs are used by the vessel crew for charting purposes and as one of the primary means of navigation. During the investigation, the vessel did not produce evidence of carrying paper charts for Port Egmont or an approved Electronic Chart Display and Information System (ECDIS) for the Port Egmont area as per the requirements of SOLAS Chapter V, regulation 27<sup>20</sup>. The ECS carried onboard is updated by shore staff when the vessel is in Montevideo, Uruguay<sup>21</sup>. Since the vessel's last port call in Montevideo, no update corrections on the ECS were carried out by the vessel crew. The ECS displayed areas around the Falkland Islands including depths of surrounding waters.
